RE: Inspection of Stormwater Management Facilities  
Tree Tops Basins #1 and #3  
UPIs #61542005271950 and 61542010370494  
Maidencreek Township, Berks County, PA

**STORMWATER MANAGEMENT FACILITIES**  
**On-Site Inspection Report**  
**MAIDENCREEK TOWNSHIP, BERKS**  
**COUNTY, PA**

**PROJECT NAME:** Tree Tops – Basin 1 & 3      **LOCATION:** UPI: 61542005271950

**PLAN NAME:** Tree Tops Subdivision Phase 3, by McCarthy Engineering Associates, P.C., dated February 24, 2004, recorded May 4, 2008

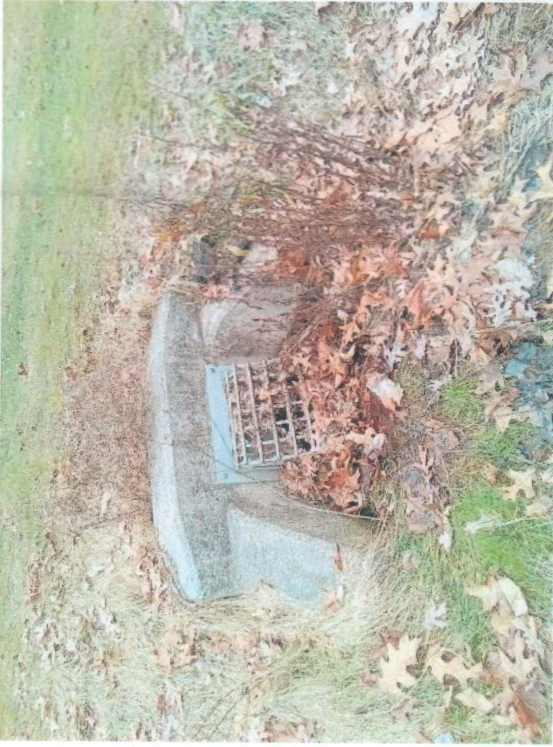
Photo 1

| Any Maintenance Required: | <input checked="" type="checkbox"/> Yes <input type="checkbox"/> No | Notes: <u>Clear leaves from in front of outlet structure trash rack. (See photo 1)</u> |

- Remove leaves in front of OS-1.
- Remove debris and weeds from riprap apron of EW101. Restore apron to original design dimensions.

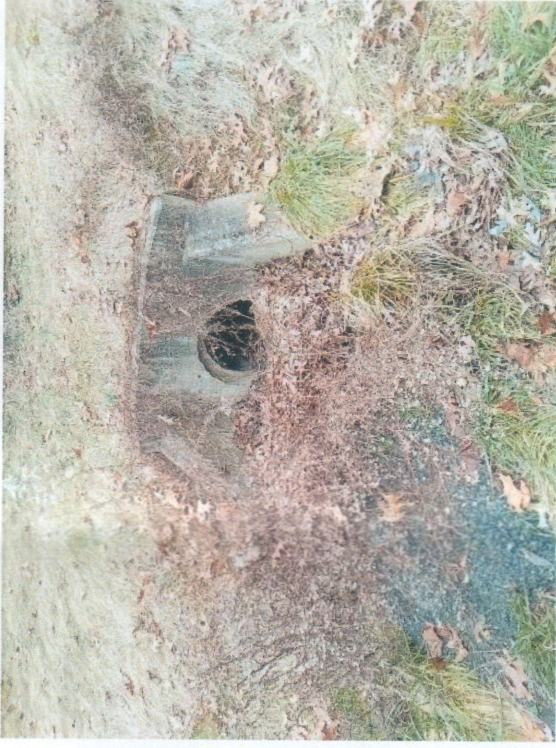
Photo 2

| Riprap Aprons: | <input type="checkbox"/> Acceptable <input checked="" type="checkbox"/> Not | Notes: <u>Riprap apron is buried under debris and weeds. This shall be cleared and the apron returned to its original design dimensions. (See photo 2)</u> |

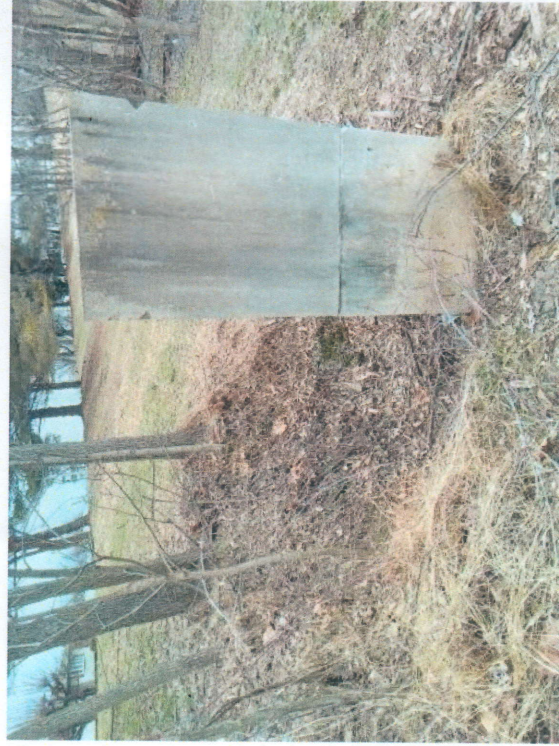
Photo 3

| Required Trash Rack: | <input type="checkbox"/> Acceptable | <input checked="" type="checkbox"/> Not | Notes: <u>Trash rack not installed. (See photo 3)</u> |
| Other Concerns: | <input checked="" type="checkbox"/> Yes | <input type="checkbox"/> No | Explain: <u>Trees growing out of the basin bottom must be removed. There is a significant amount of dead tree limbs in the bottom of the basin that need to be removed. (See photos 5, 6, &amp; 7) The basin side slope is beginning to erode behind the outlet control structure. (See photos 3 &amp; 8)</u> |

- Install and securely anchor a trash rack over the outlet structure. Minimum opening sizes should be 6" x 6".
- Remove the trees and accumulated debris at the bottom of the basin.
- Reshape flow paths from the endwalls to the outlet pipe, maintaining a constant slope and cross section.
- Restore the basin side slope behind the outlet control structure. Slope should be at a 3:1 grade.
- Restore the riprap aprons to their original design dimensions, adding stone as necessary.

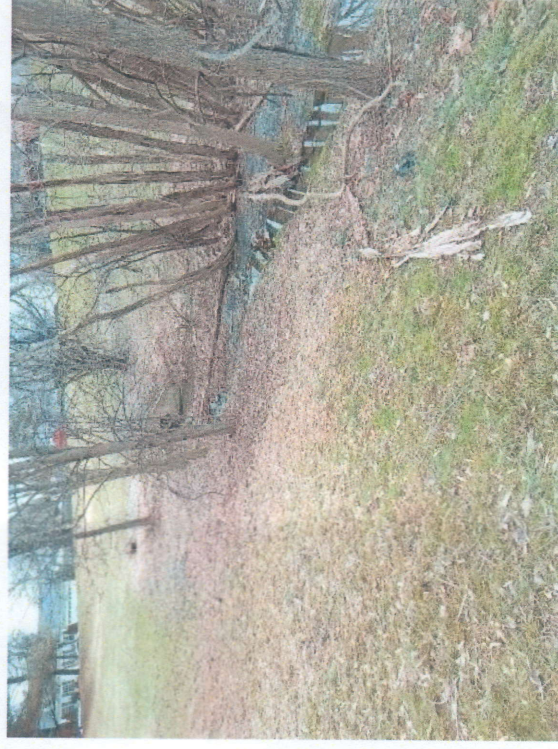
Photo 4

| Positive Drainage Provided: | <input type="checkbox"/> Acceptable | <input checked="" type="checkbox"/> Not | Notes: <u>Basin is holding water due to trees &amp; large rock downstream of DW EW 4. (See photos 4, 5, &amp; 6)</u> |

| Any Maintenance Required: | <input checked="" type="checkbox"/> Yes | <input type="checkbox"/> No | Notes: <u>Basin bottom shall be reshaped with an even slope from endwalls to outlet pipe.</u> |

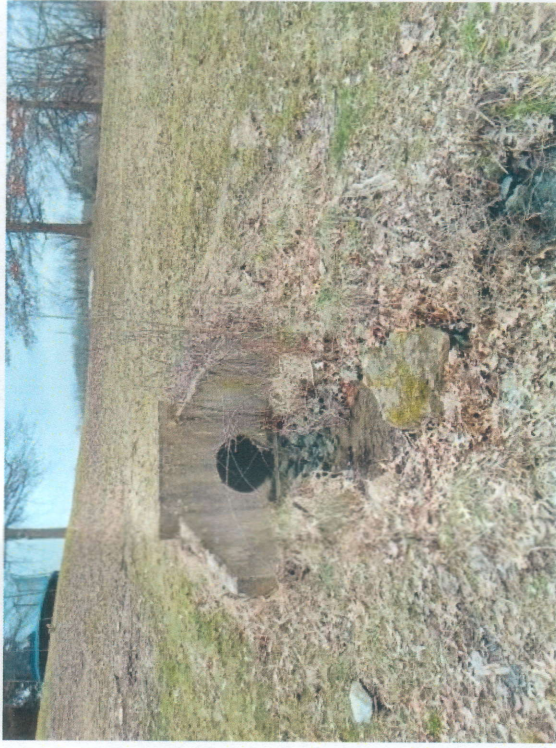
Photo 6

| Riprap Aprons: | <input type="checkbox"/> Acceptable | <input checked="" type="checkbox"/> Not | Notes: <u>Riprap aprons have been washed away, facilitating scour holes immediately downstream of the enwalls. Riprap aprons shall be restored to their original design dimensions. (See photos 6 &amp; 9)</u> |
