RE: Inspection of Stormwater Management Facilities

Tree Tops Basin #3 UPIs #61542005271950

Maidencreek Township, Berks County, PA

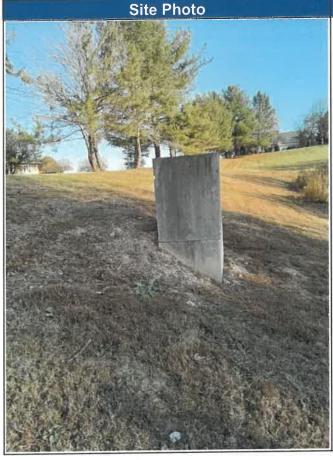
Photo 2 View of outlet control structure.

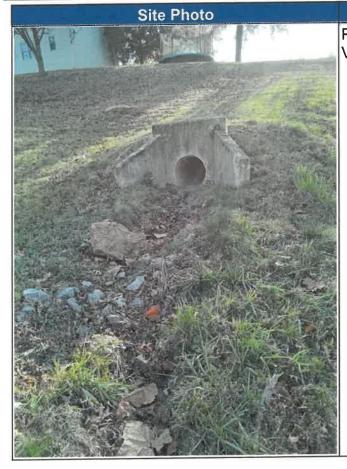
Photo 3 View of endwall 4. Riprap apron to be reestablished.

- > Tall grasses in the bottom of the basin shall be removed.
- > Riprap aprons to be reestablished.
